NASA/TM-2009-215785
NESC-RP-07-47/07-005-E

Space Transportation System (STS)-117 External Tank (ET)-124 Hail Damage Repair Assessment

NASA Engineering and Safety Center Technical Report	Document #: RP-07-47	Version: 1.0
Title:	STS-117 Hail Damage Repair Assessment		Page #: 1 of 113

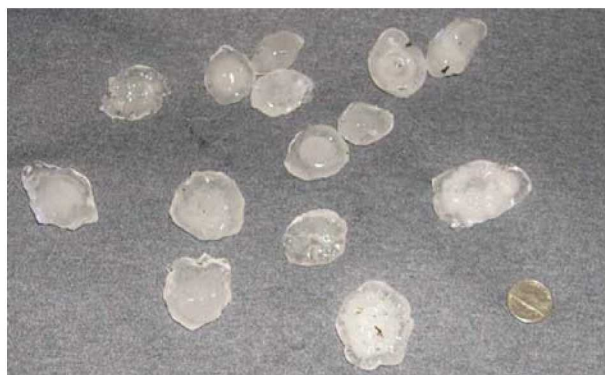
Severe thunderstorms with associated hail and high winds struck the STS-117 stack on February 26, 2007 while at Launch Pad 39. Peak winds were recorded at 62 knots with hail size ranging from 0.3 inch to 0.8 inch in diameter as shown in Figure 6.1-1. The NCFI 24-124 foam on the LO2 tank ogive acreage and the ET intertank incurred significant damage. NCFI on the ET intertank and PDL 1034 foam of the LO2 IFRs suffered minor damage, as did the LO2 tank cable tray SLA. An example of the resulting damage is shown in Figure 6.1-2.

Figure 6.1-1. Hail from the February 26, 2007 storm [ref. 26]

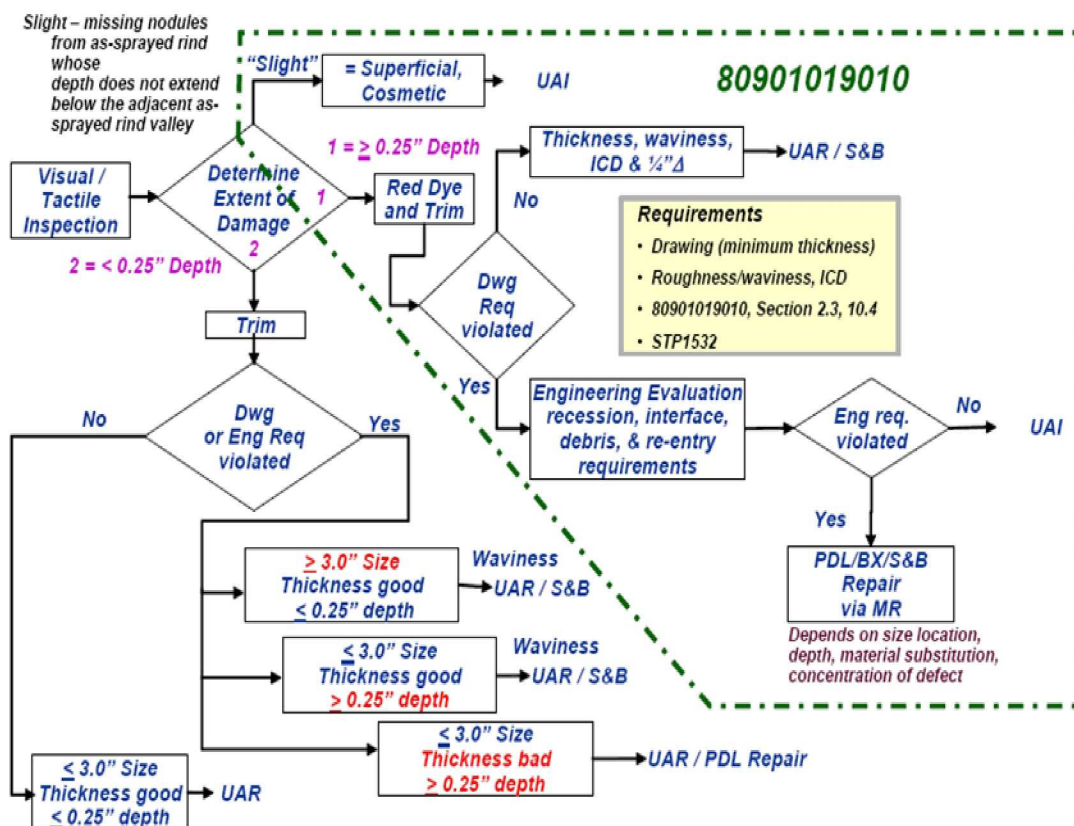
The flowchart in Figure 6.2-1 outlines the initial plan for dispositioning TPS damage [ref. 9]. If the damage was superficial (cosmetic only), no repair was performed. If the damage depth was less than 0.3 inch, the crushed NCFI was removed and no further repair performed. PDL 1034 repairs were performed on damage greater than 0.3 inch in depth. Surface roughness and waviness criteria outlined in 9010 were modified to minimize the amount of sanding required. In two locations where size and density of PDL repairs would have resulted in violation of 9010 or pertinent Interface Control Document (ICD) requirements, large-area BX-265 spray repairs were performed. Minor violations of 9010 were accepted by MRB disposition on a case-by-case basis.

Figure 6.2-1. Preliminary Roadmap for ET-124 Repair Evaluation Process [ref. 9]

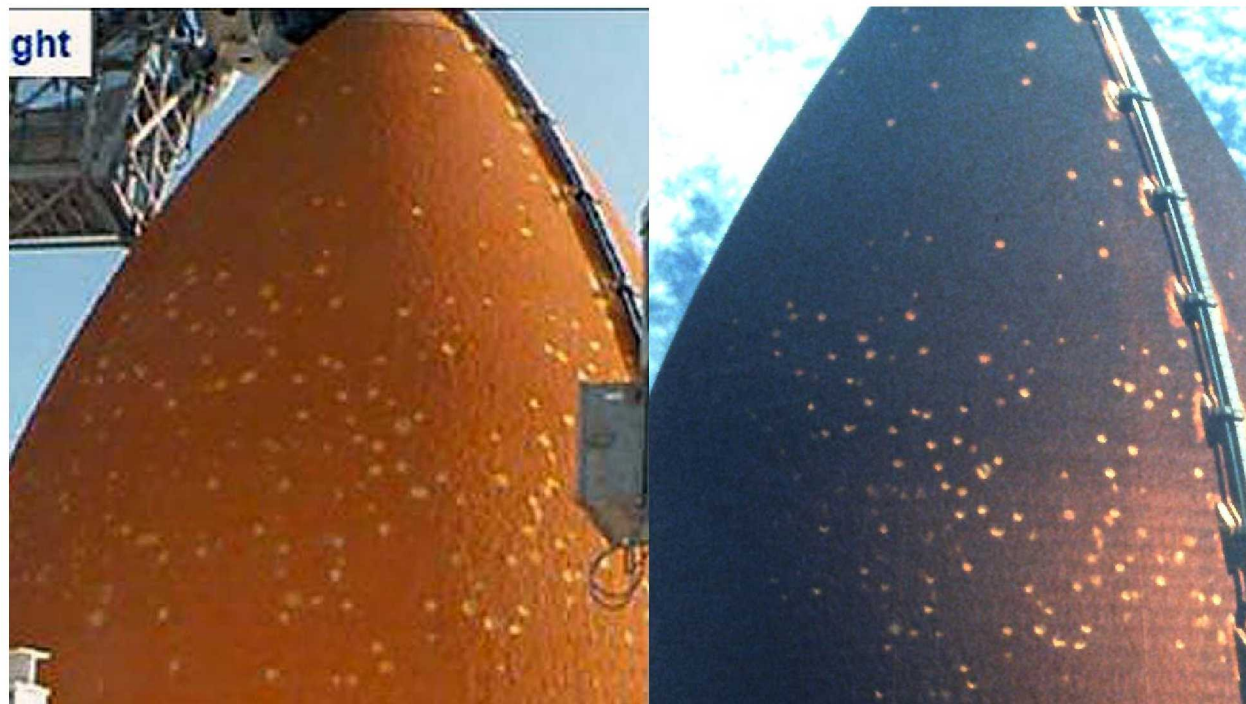
The LO2 tank acreage had visible condensate but no ice or frost formations. All hail repairs were intact and exhibited no thermal shorts. No anomalies were detected on the inter-tank. The LH2 tank acreage had condensate but no ice or frost formations. After the pad was cleared for launch, the Ice Inspection Team continued to monitor the vehicle with remote cameras and infra-red radiometers. There was no ET acreage ice observed and no noticeable increase in protuberance icing was detected. The report did indicate that there was extensive surveillance of the hail damage to verify repair integrity and the absence of ice formation.

Figure 6.2-4. STS-96/ ET-100 Pre- and Post- Launch Comparison

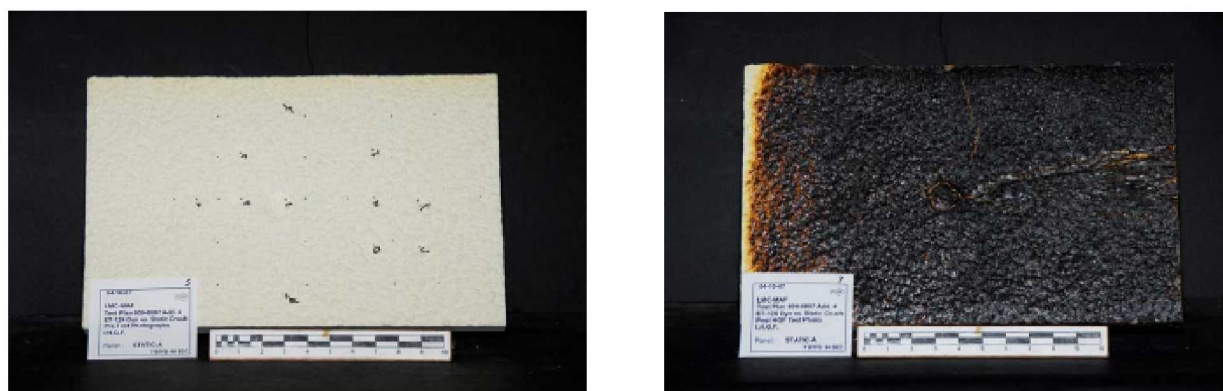
envelope the STS-117 hail event due to significant differences in magnitude, rate, and cross-sectional area over which energy was dispersed in those test articles, NESC recommended additional tests be conducted on panels designed to simulate the STS-117 damage. These tests showed a linear relationship between energy of impact and depth of TPS damage consistent with the STS-96 results, with the bulk of the crushed foam found within about 0.2 inch of the defect bottom [refs. 5, 24]. Hot gas tests were conducted on un-repaired NCFI panels subjected to STS-117 simulated damage (both static and dynamic) and no significant debris release was observed [ref. 8]. Recession rates for these panels were in-family.

Figure 7.2-1. Hot Gas Test of NCFI Panel Subjected to Static Loads Simulating STS-117
[ref. 8]

On the basis of these tests, NESC concurs that significant debris release or accelerated TPS recession due to residual crushed foam is unlikely.

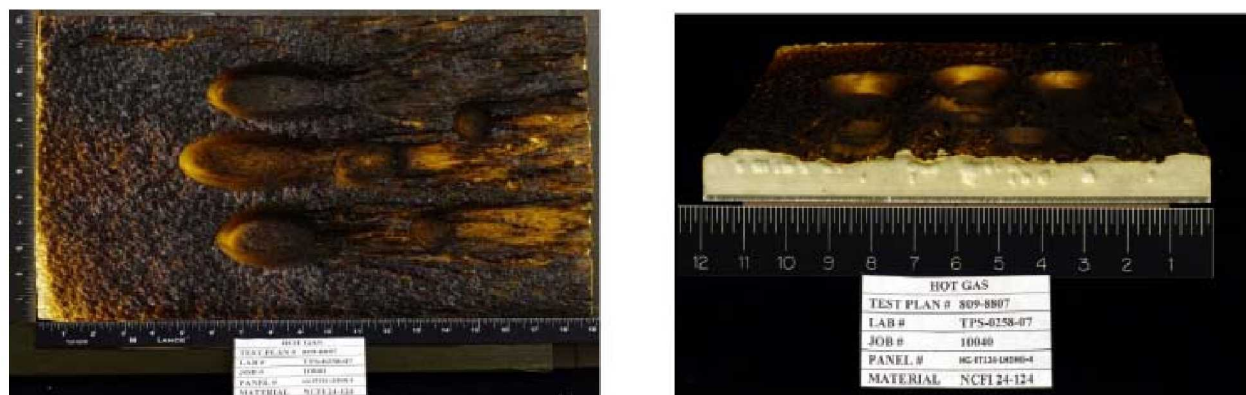
Figure 7.3-1. Hot Gas Test of NCFI Panel Containing Multiple Steep-Wall Sand and Blend Repairs [ref. 7]

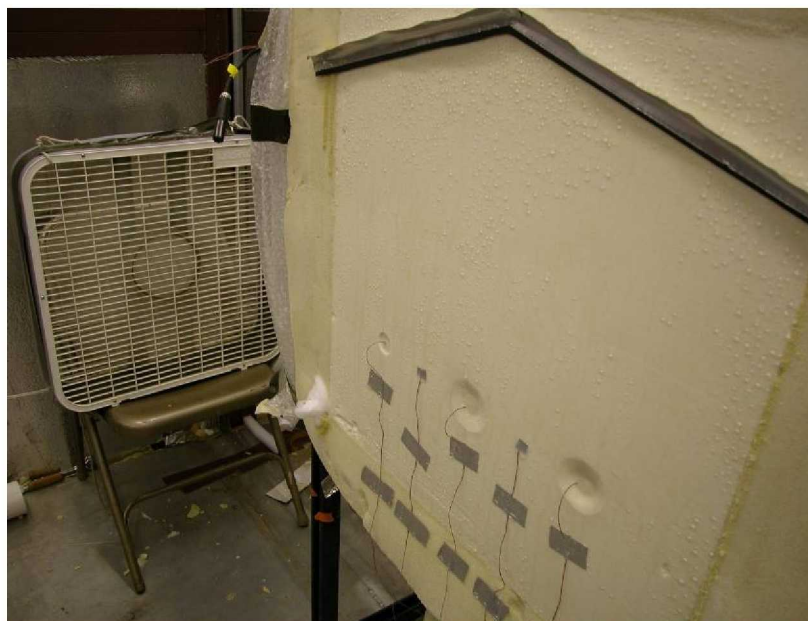
Figure 7.3-2. Sand and Blend Criteria Icing Test [ref.10]

NESC investigation of the historic weather at KSC showed that the 85 percent cutoff coincided with wind speeds that would cause the heat transfer on the LO2 ogive to be dominated by forced convection; as a consequence, there was an issue with directly using the results of a natural convection test with limited forced convection to assess the potential for S&B icing. NESC performed a physics-based non-dimensionalization of the icing potential to allow a relative assessment of the S&B icing potential from all the repair sites (Appendix F). The analysis showed that the three repair sites that had been re-designated for PDL did indeed have icing potential that exceeded other S&B sites, thus confirming the ET Project selection. The analysis also identified 11 other repair sites that had been selected for S&B that had icing potential which exceeded that of sites that had already been designated for PDL repair. NESC recommended these sites be repaired with PDL, and ET Project accepted the recommendation. Because the tests performed to establish; the PDL versus S&B repair criteria were not fully representative of the launch pad heat transfer physics, the possibility remained that launch probability due to icing could be substantially less than 85 percent. To address this concern, NESC performed a sensitivity analysis using the 30-year KSC weather set and demonstrated that, even if the physics used to set the cutoff was off by a factor of two, the probability that day-of-launch icing would not exceed Launch Commit Criteria (LCC) requirements still exceeded 55 percent. This assessment is detailed in (Appendix G).

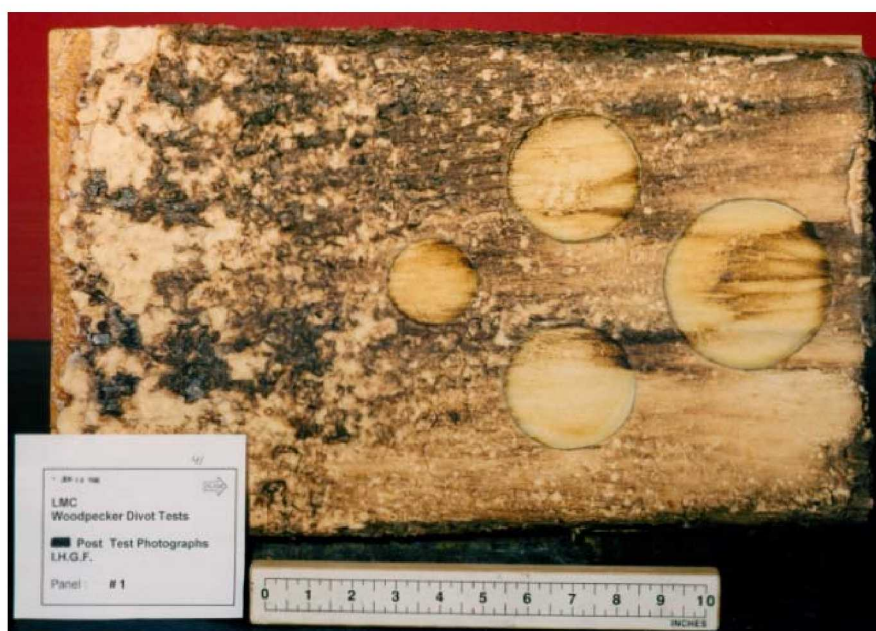
Over 900 PDL repairs were made on the ET LO2 tank, which is approximately an order of magnitude more than normal. In general, the specified PDL repair density limits (repairs per square foot and distance between repairs) have been test-validated and demonstrated to have no effect on NCFI integrity.

Figure 7.3-3. STS-70 Multiple PDL Repair Test Panel [ref. 3]

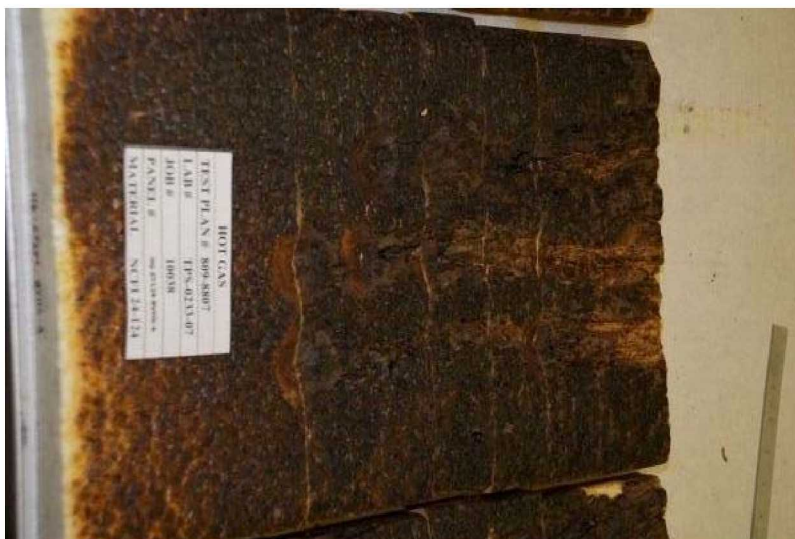
PDL material used on ET-124 had to be requalified due to a vendor change. Testing done to support the requalification also demonstrates acceptable performance of multiple PDL and S&B repairs in an environment similar to that expected on the LO2 tank at ascent [ref. 5].

Figure 7.3-4. Hot Gas Test of PDL Repair Panel Containing Multiple Repairs [ref. 3]

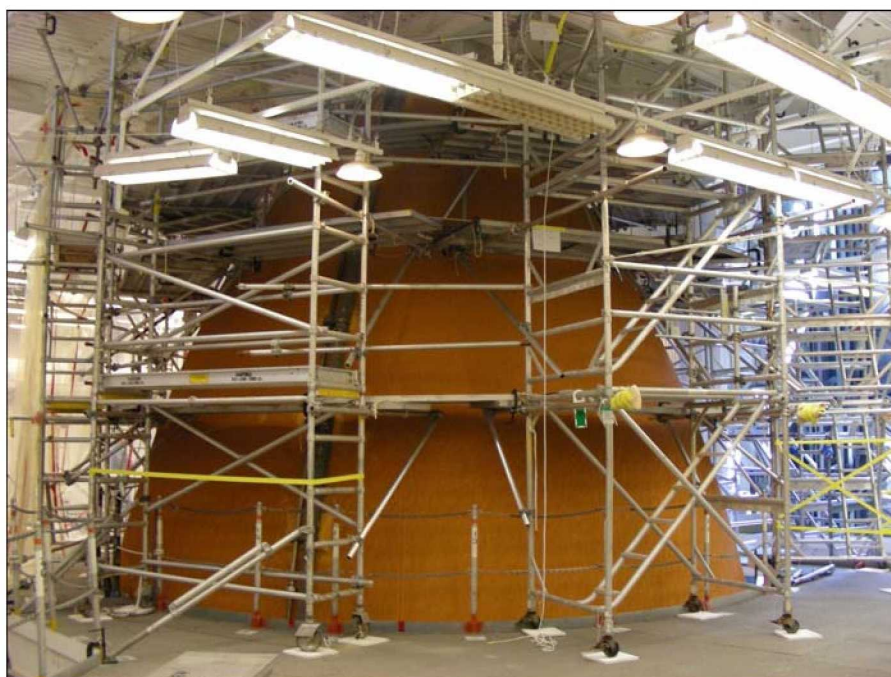
Figure 7.3-5. ET-124 Access and Lighting in the VAB

temperature is specified, the procedures did not include verification steps to ensure this pour time was not exceeded and recommended quality inspector timing of multiple PDL pours from a single syringe to the procedure development team. The team also recommended that red dye application procedures be strengthened with specific work steps in lieu of notes. These recommendations were subsequently implemented.

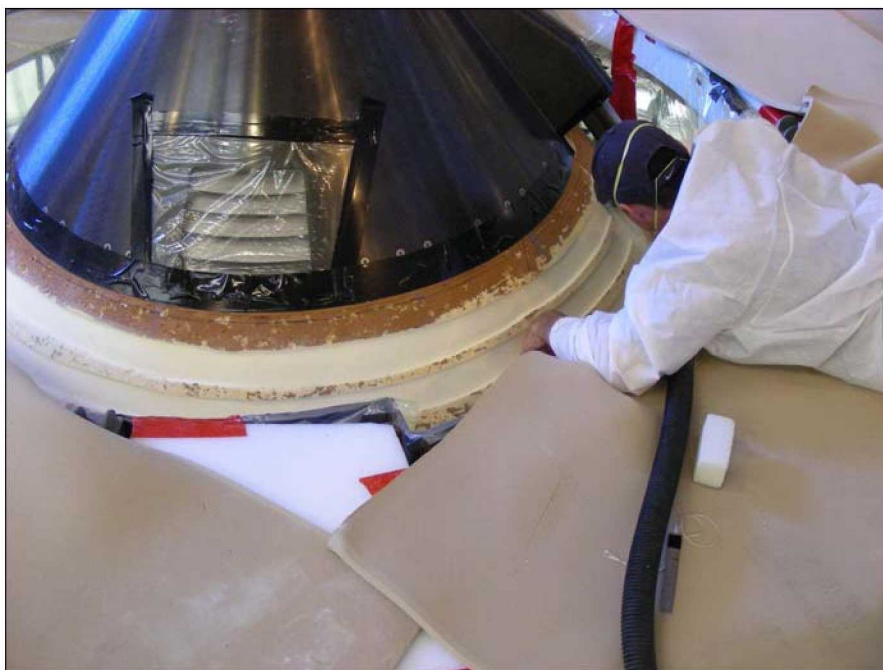
Figure 7.3-6. ET-124 Nose Cone Area Access

Training, work area access, and lighting were reviewed. The PDL repair certification / re-certification procedures used at KSC and MAF are slightly different. Most notably, the KSC training procedures do not include steps for dissection and analysis of PDL repairs, and the test panels used for KSC training are not made with NCFI foam. While access to the work area was adequate, NESC noted the lighting in the LOX ogive work area was insufficient for some tasks such as inspection of Conathane® application and identification of damaged foam prior to red dye application. NESC recommended improvements to lighting in the work areas, and that recommendation was accepted and implemented.

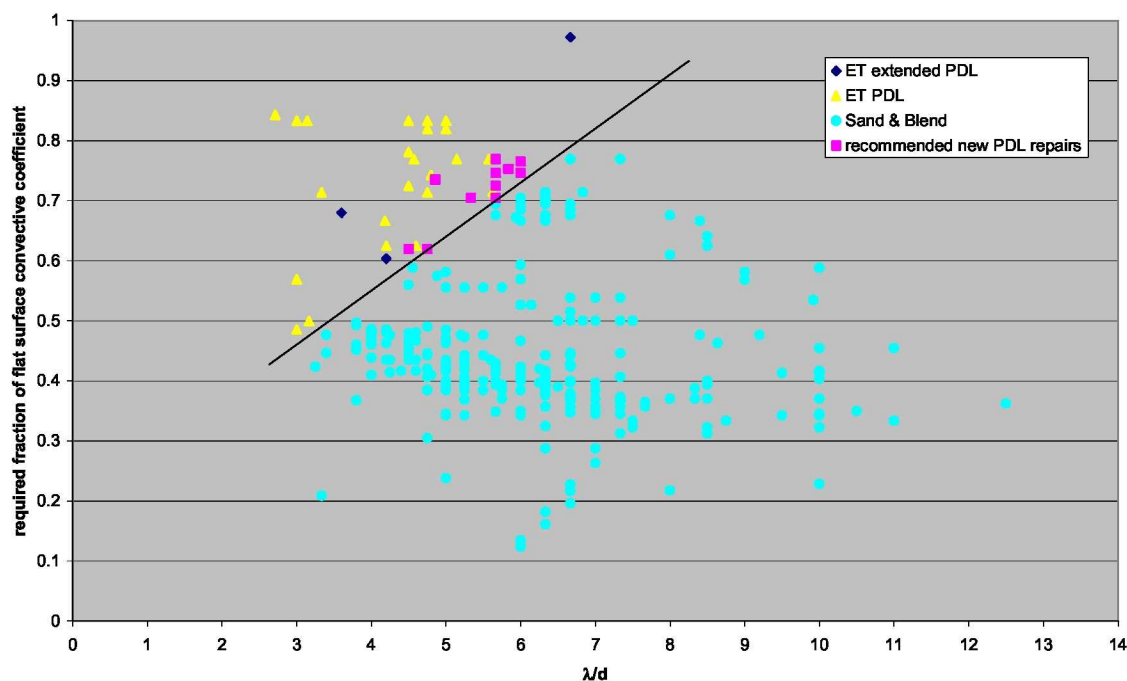
To address the repair method overlap, a cutoff line was drawn encompassing all the ET Project-recommended PDL repairs as shown in Figure J-6. The line has the expected upward slope as discussed in the previous section.

Figure F-6 – Repair Sorting and Recommended Augmentation

Figure J-6 also shows 11 repairs that were recommended as S&B by the ET Project that are above the dividing line and thus have icing potential that exceeds that of sites that had been designated for PDL repair. The NESC recommended to the project that these sites also be repaired with PDL. The ET Project accepted the recommendation.

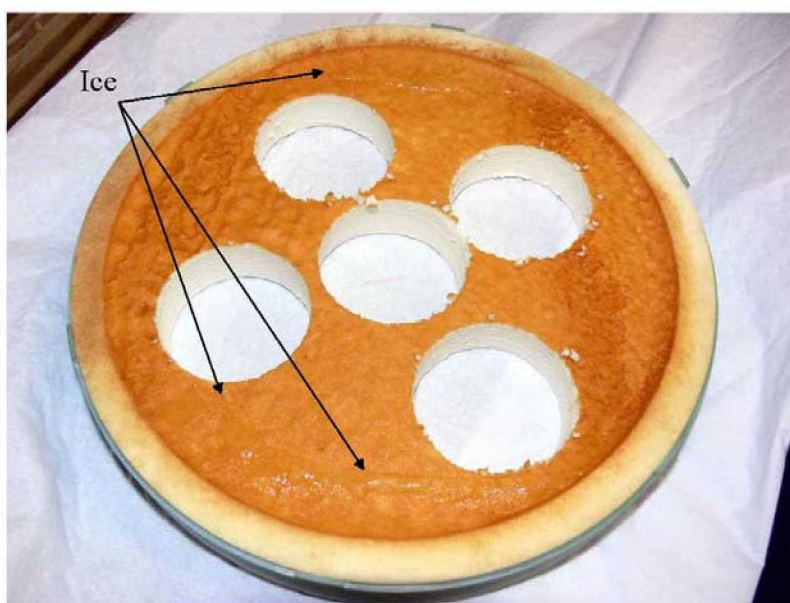
Figure 5. Photograph of 15 month weathered BX-265 foam immediately after all core sections were taken. Note that ice from CMU testing was still present.

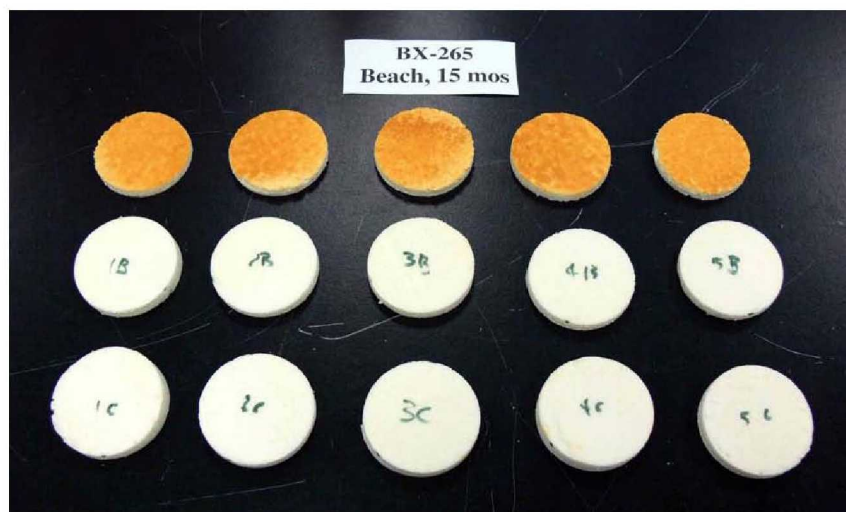
Figure 6. Photograph of dissected cores of BX-265 15 month weathered after drying.

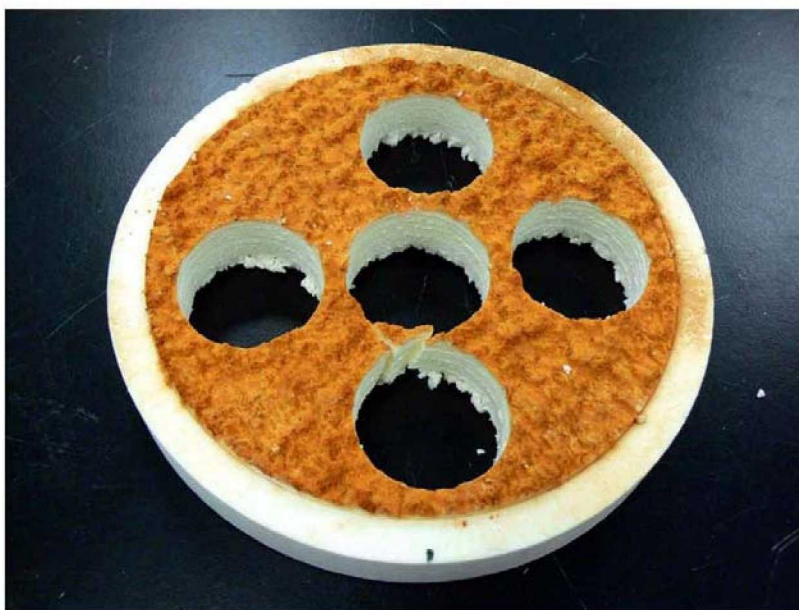
Figure 9. Photograph of 15 month weathered net spray NCFI 24-124 after coring and drying overnight.

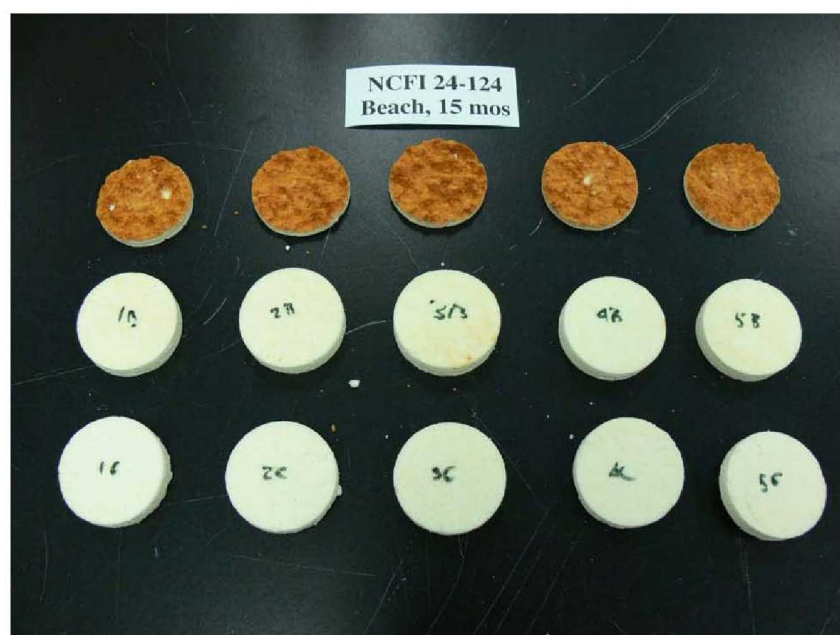
Figure 10. Photograph of dissected cores of net spray NCFI 24-124 15 month weathered samples after drying.

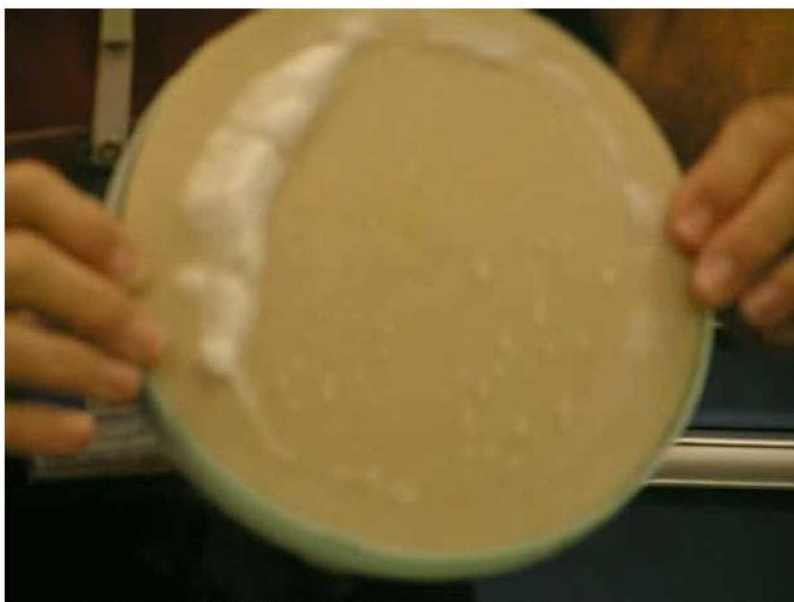
Figure 12. A photograph of GFT flexible polyimide foam immediately after removal from Cryogenic Moisture Uptake test apparatus. Note the ice/frost and water drops evident on the warm surface.

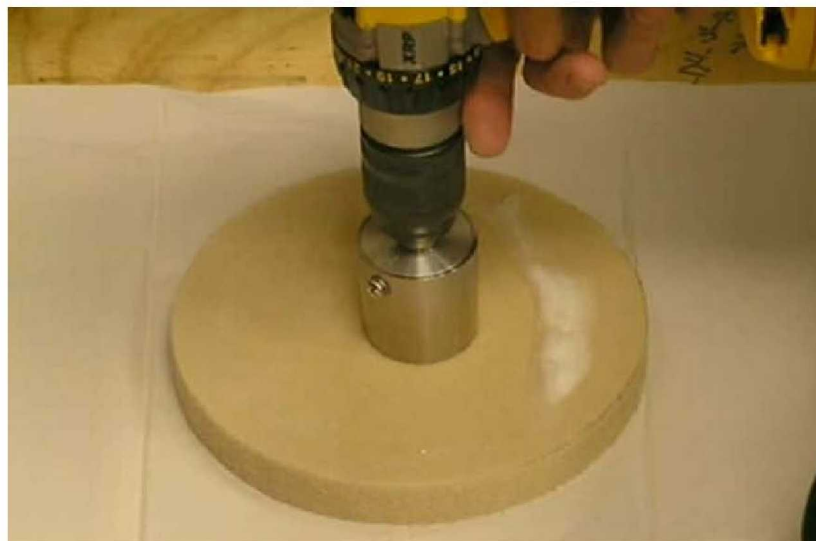
Figure 13. A photograph two minutes after removal from CMU apparatus the first core was drilled out. Note the ice/frost section.

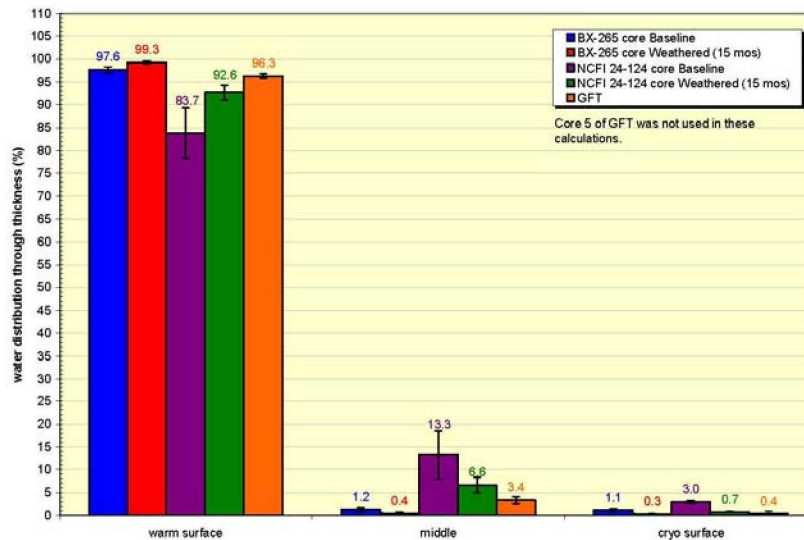
Figure 16. Core data of all samples. Core data strongly indicates that though samples had different amounts of water weight gain how the water was distributed was remarkably similar. The 5th core for GFT was omitted because it was deemed an outlier.

Test results indicate that water distribution throughout the thickness of “closed cell” foam samples in comparison to “open cell” foam samples was similar. Frost formation and liquid water condensation are simply a function of dew point, surface temperature, and surface area. Water/frost deposition does change the local humidity level within the foam thus to maintain equilibrium humidity conditions water vapor does need to transport to the localized area with reduced humidity. This mass transport seems to be a small driver as indicated by the data (Figure 16.). Though the GFT foam has the ability from a mass transport point of view to gain weight in cryogenic section C and middle section B that does not occur. What probably occurs in these cold sections is that all of section C is below

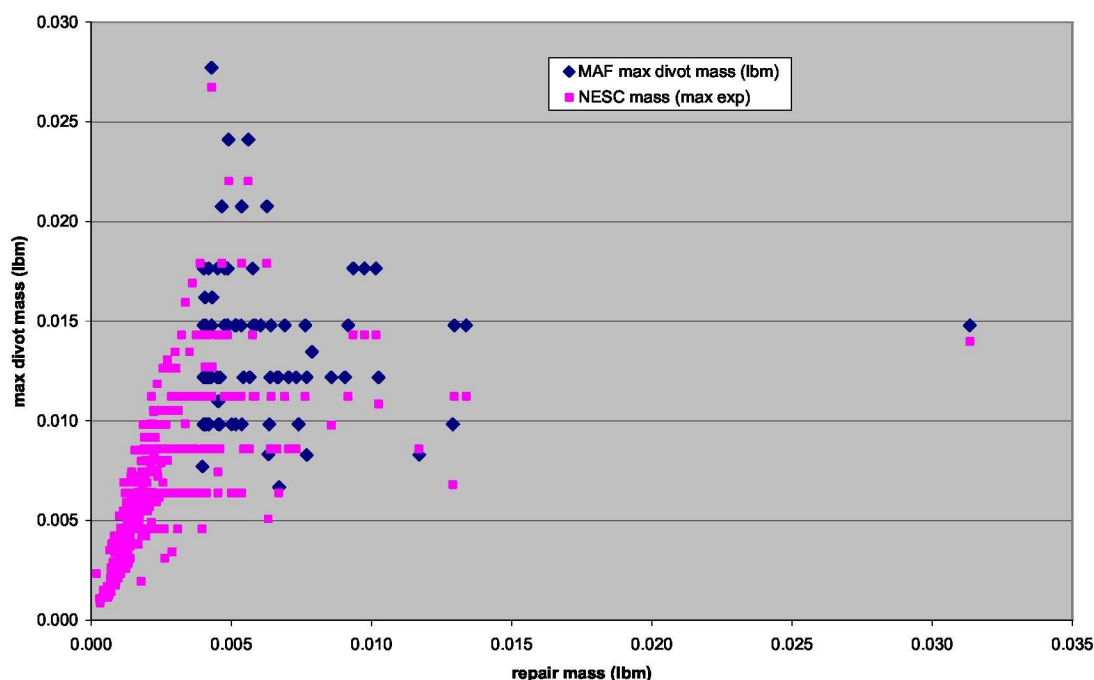
Figure I-1 - Maximum Expected Divot Masses Using the Two Algorithms

Figure L-1 plots the divot masses generated by the ET Project analysis and the NESC analysis. Even the figure shows that a very large number of possible divots greater than the deterministic limit of 0.004 lbm are not calculated are by the ET Project's algorithm.

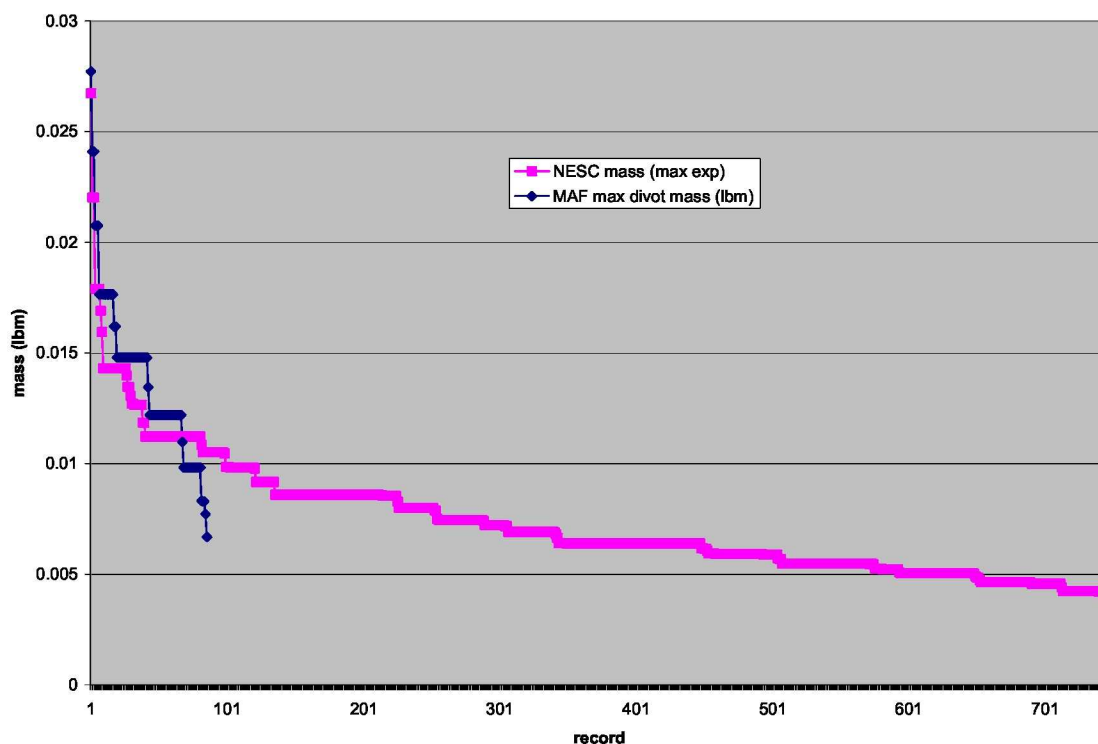
Figure L-2 – Sorted Divot Masses

Figure L-2 plots sorted defect masses greater than 0.004 lbm obtained by the two algorithms. The figure shows the additional smaller masses between 0.004 and 0.010 lbm that are captured by the NESC method.

Using the NESC method allows all the maximum expected divots that exceed 0.004 lbm to be captured, generating the most accurate possible input to the PRA. The NESC recommended to the Space Shuttle Systems Engineering and Integration (SE&I) Office that the NESC method be used to capture the maximum expected divot masses from the PDL 1034 repairs. The SE&I Office accepted the recommendation.
